Effects of sewage water disposal on the biophysical dynamics of a South African temporarily open/closed estuary

**R Perissinotto, D Stretch, I Kibirige, C Thomas, A T Forbes
University of KwaZulu-Natal, Durban, South Africa**

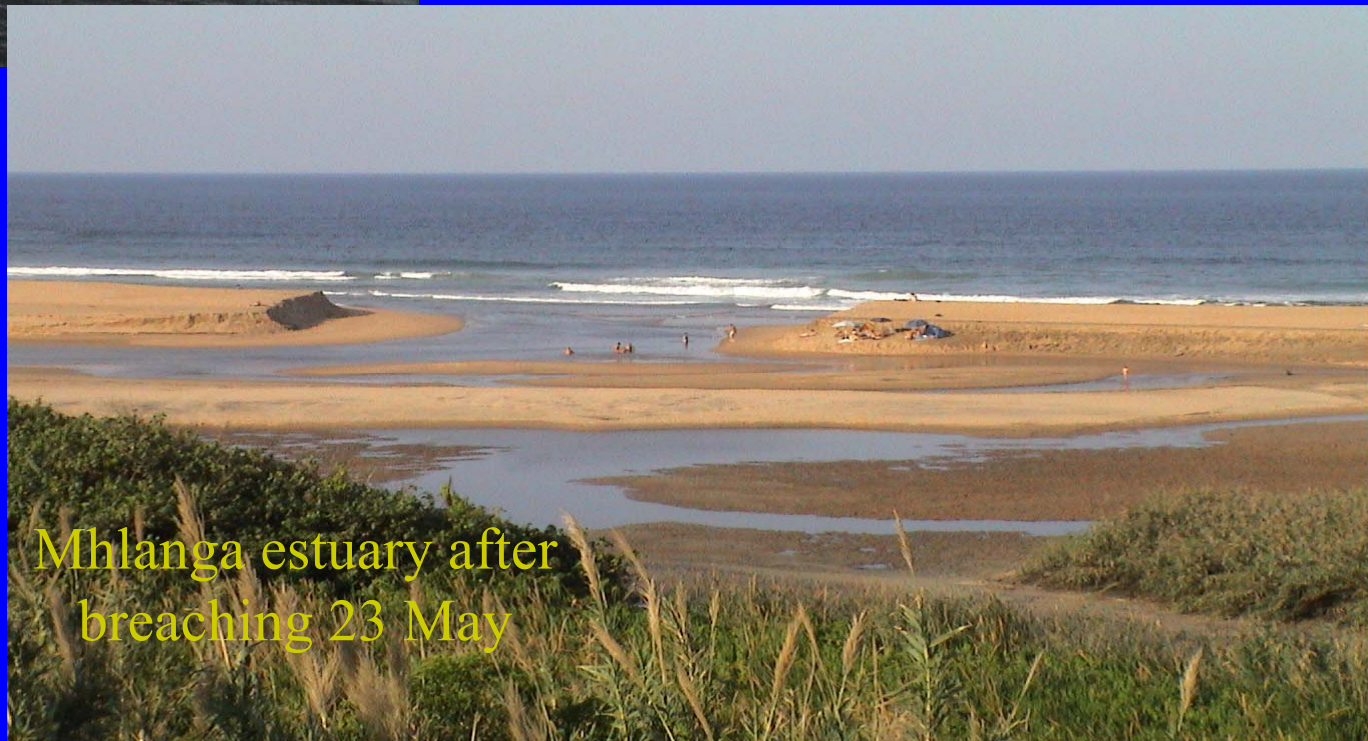
Mhlanga estuary after breaching 23 May

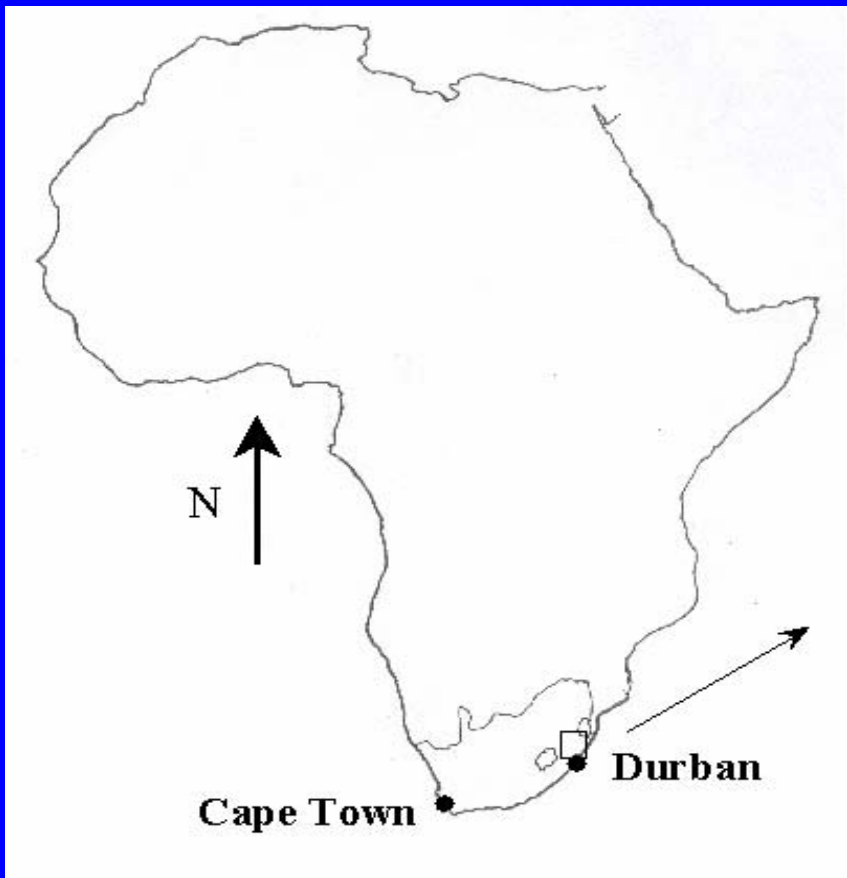
Mhlanga Estuary and its Catchment

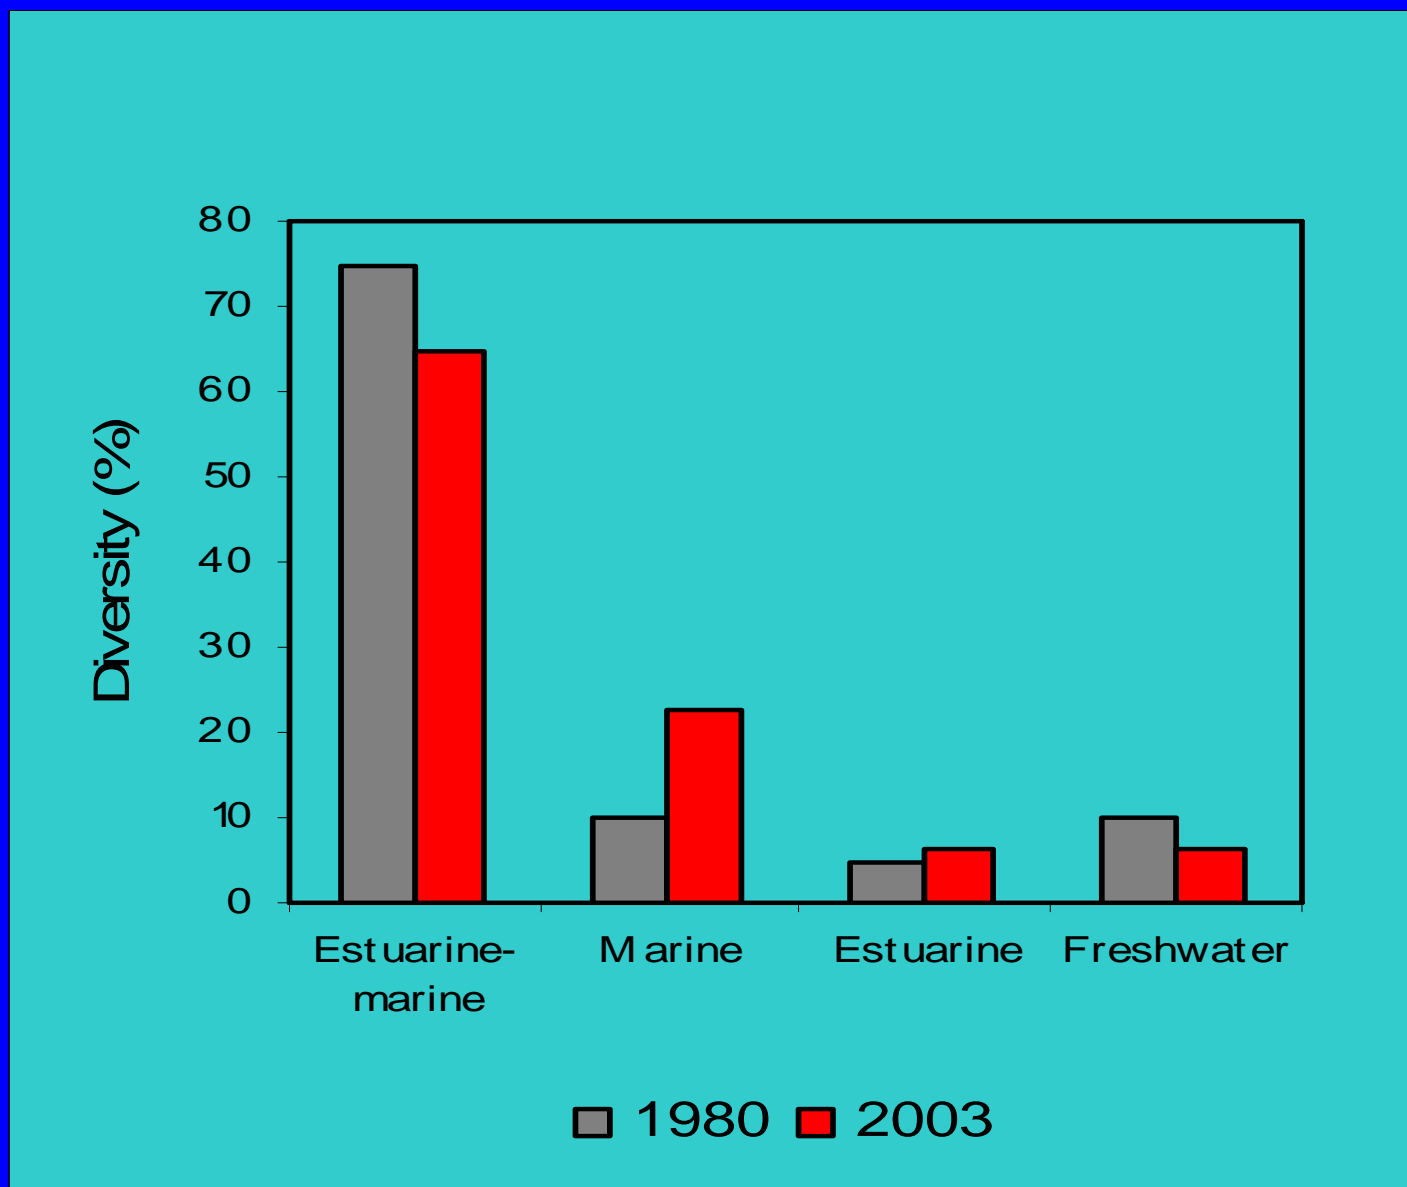
FISH DIVERSITY - 1980 vs 2003 (Fig. 7.4)
